# CityDiff Sample Report

Two-week imagery comparison and permit-record triage

Imagery interval: May 17, 2026 - May 31, 2026 (14 days)

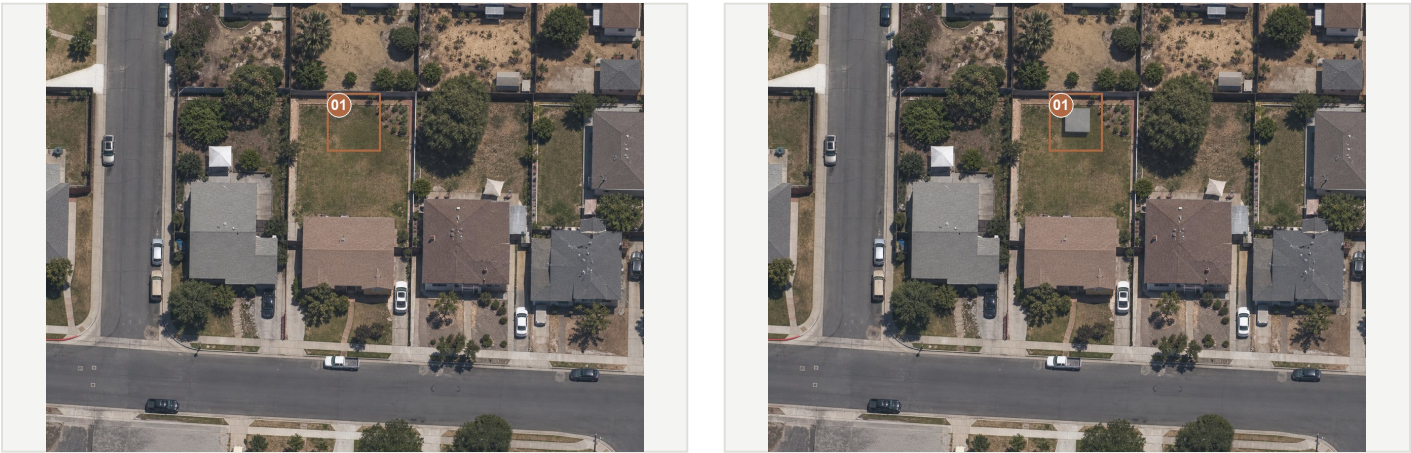
# Finding 01

Detached backyard structure

Review priority: HIGH

A detached roofed footprint is visible in the rear yard in the newer image and is not visible in the older image.

No corresponding accessory-structure record was found in the available permit dataset.

Confirm recent applications and determine whether the observed structure falls within local permit requirements.

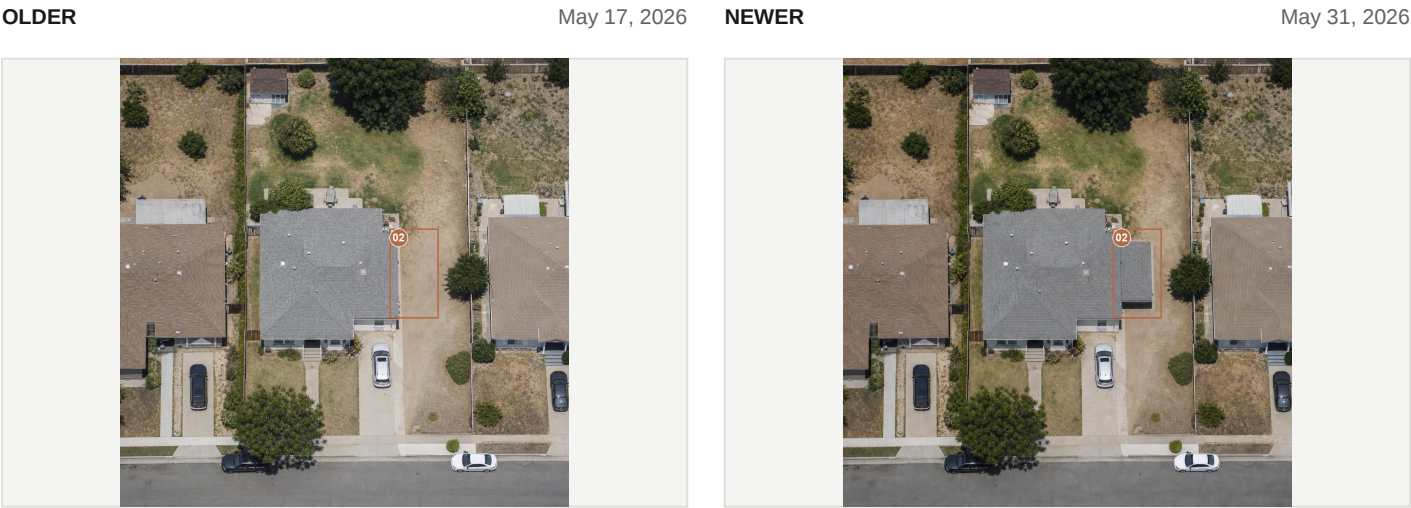
# Finding 02

Roofed side addition

Review priority: MEDIUM

A roofed footprint is visible beside the central residence in the newer image where an open side yard was previously visible.

BLD-25-0077 - interior remodel and window replacement; status: active.

The parcel and timing overlap, but the available work description does not clearly include an exterior footprint addition.

Review the permit scope or plan set before deciding whether additional action is warranted.

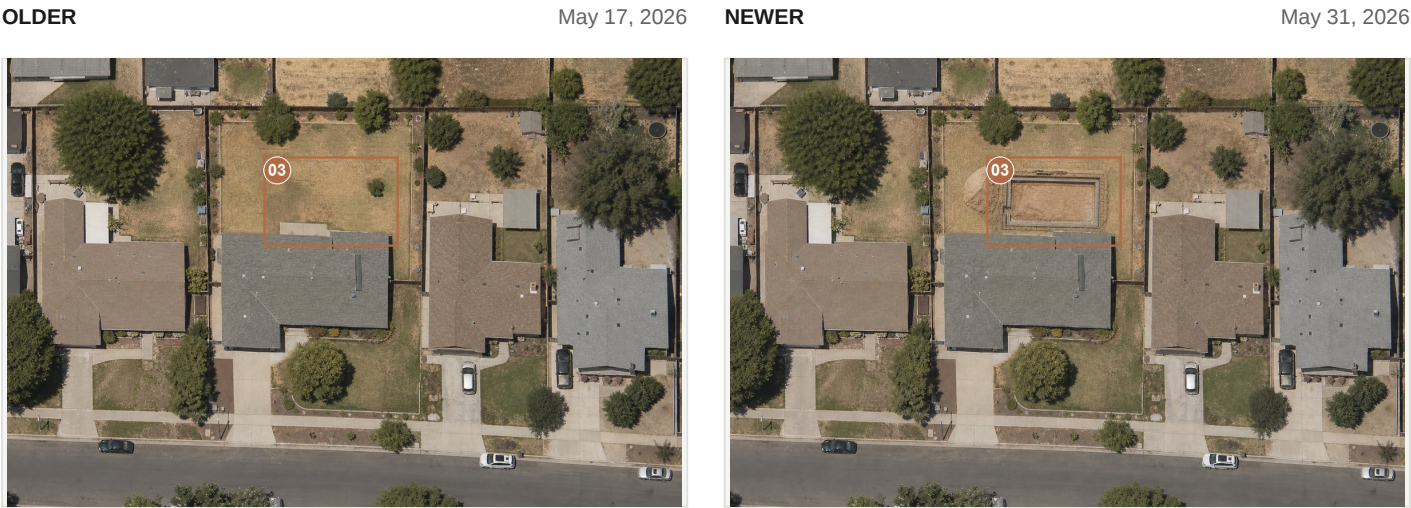
# Finding 03

Pool excavation in progress

Review priority: MEDIUM

A rectangular pool-shaped excavation, partial perimeter forming, and an adjacent spoil pile are visible in the rear yard in the newer image.

No corresponding pool or spa permit record was found in the available permit dataset.

Confirm recent applications and determine whether the excavation is associated with an active permit.

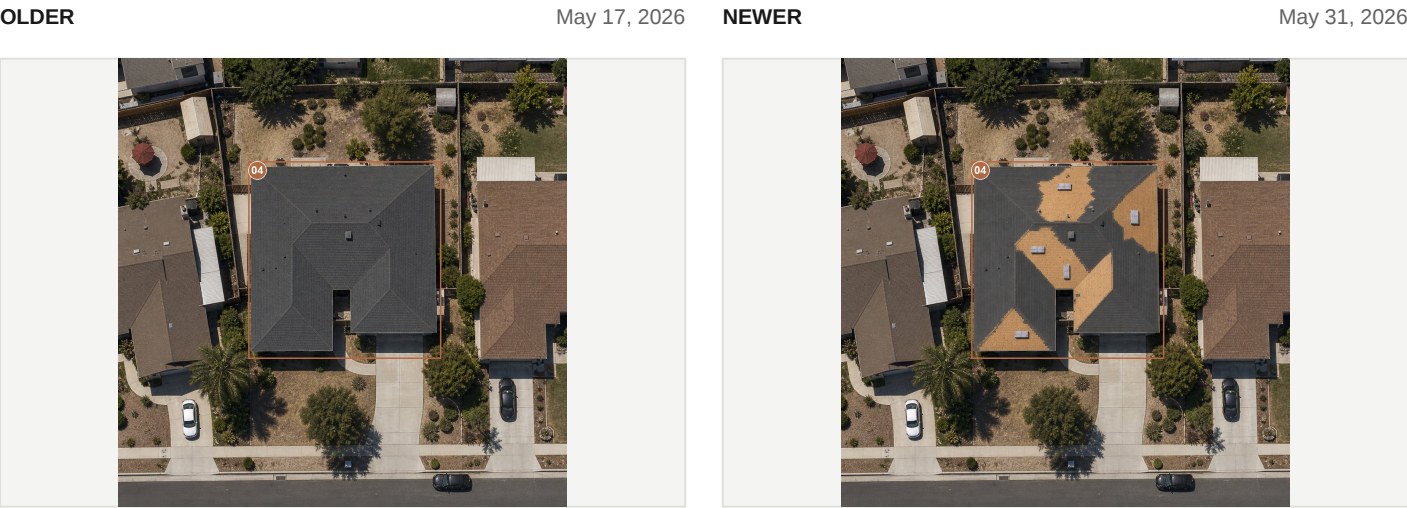
Finding 04

Active residential re-roofing

Review priority: LOW

**Observed change**  
 Part of the central roof appears stripped to orange-tan underlayment, with roofing materials visible in the newer image.

**Records searched**  
 Municipal Building & Safety records through Jun 02, 2026; parcel ID, address key, work type, and issue date.  
**Permit record**  
 RERF-26-0142 - residential re-roof; issued May 22, 2026; status: active.  
**Match basis**  
 Same parcel, compatible work description, and overlapping imagery interval.

**Suggested staff check**  
 No immediate action. Staff may confirm that the visible work is within the permit scope if desired.
